Following the full survey and documentation of all existing conditions at Building 18 in Magnusen Park for the new Outdoors For All facility, I have prepared the following report. There are two main window types/vintages present. The ground floor and a couple of the second-floor windows are of an older and more traditional style of steel window with the predominant windows at the second level appearing to be newer and in not as good condition.

Outdoors for All Window Remediation Summary and Recommendations

BUILDING 18 WINDOW SURVEY

**Rafn- BLDG#18
WINDOW SURVEY**

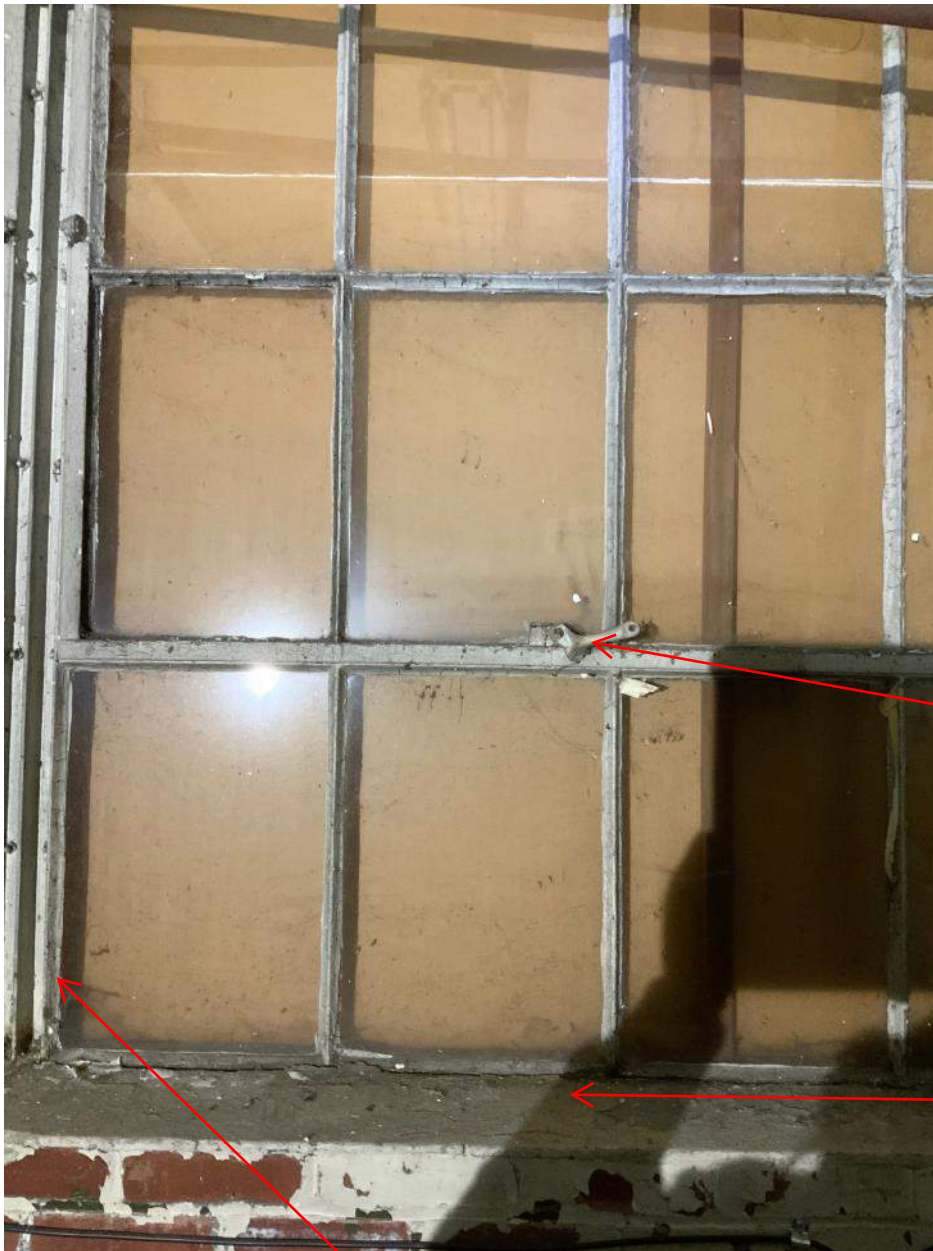
Painted hardware
appears intact

Sill backfilled with
mortar

Interior Putty Glaze

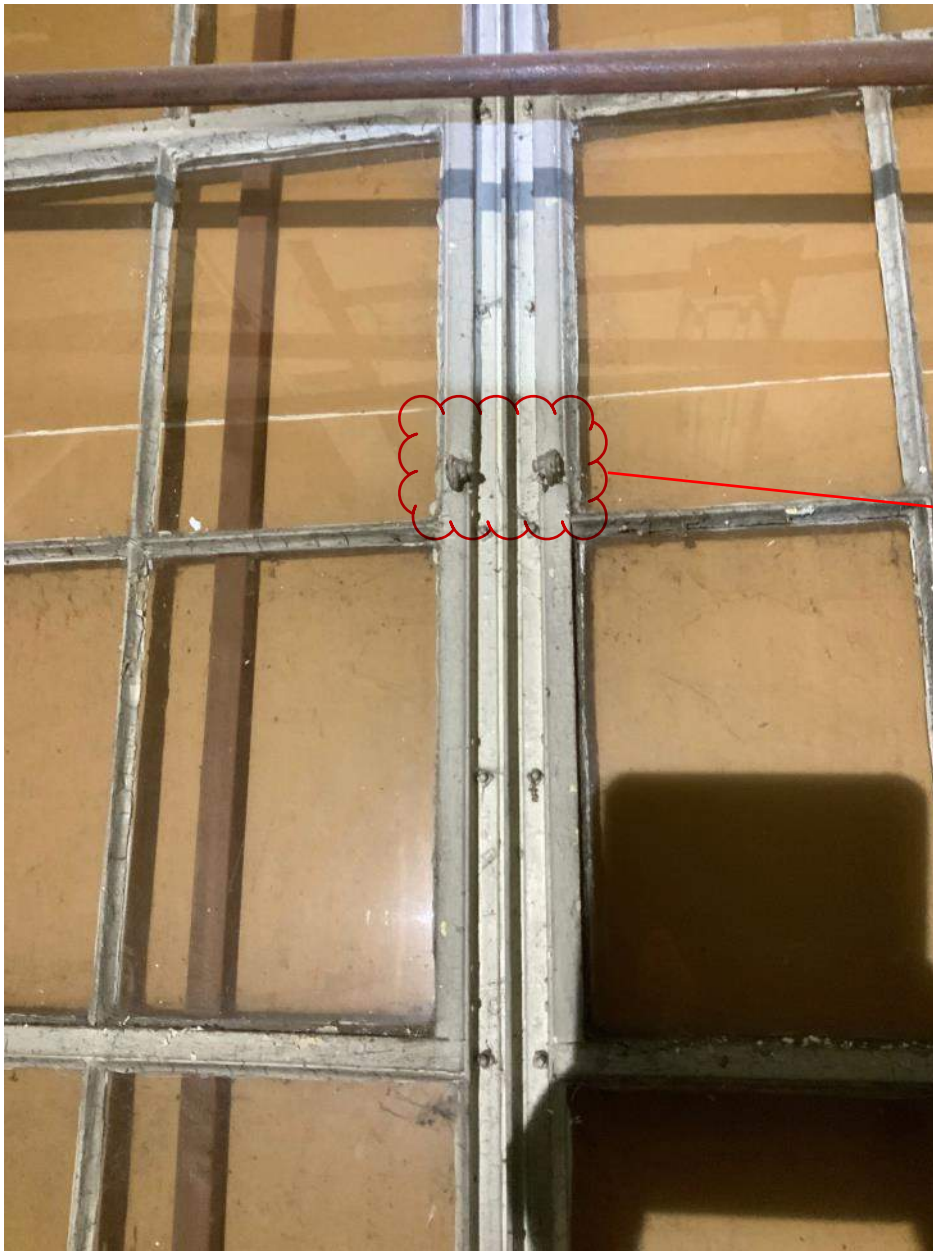
Hinge Location for
Center Pivot Steel
Awning Sash

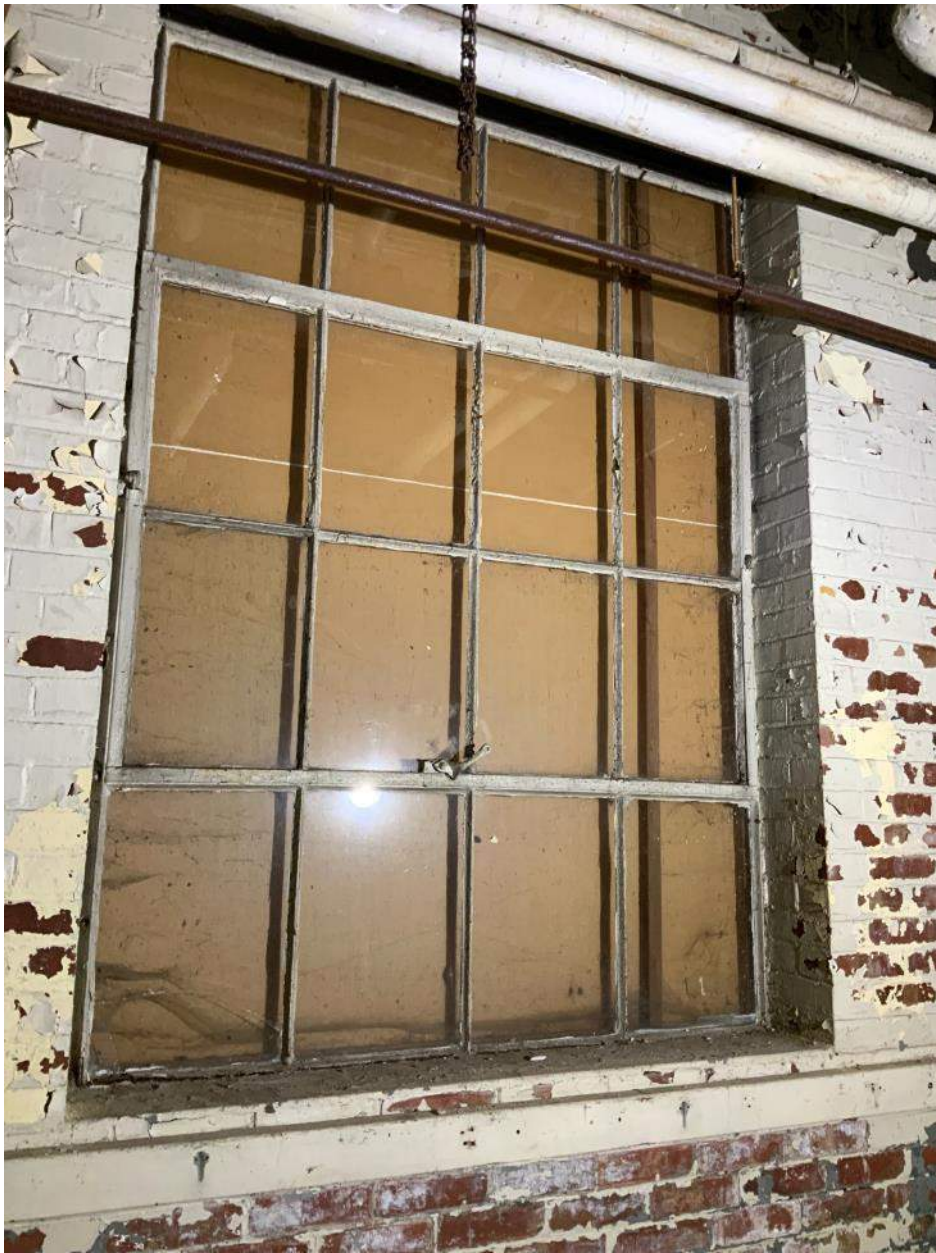
Rust and
deterioration
beginning at left side
of stool.

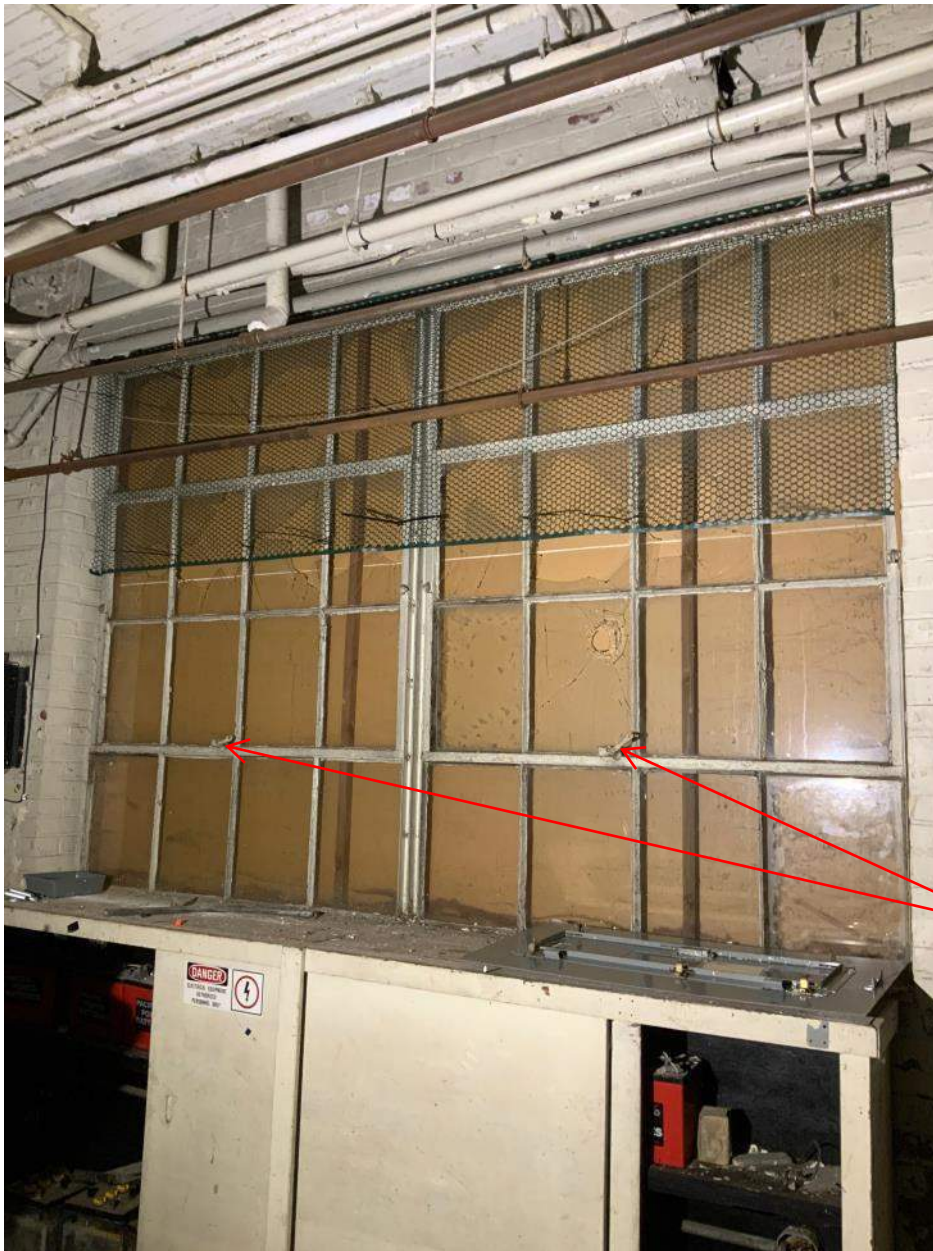
Hardware intact

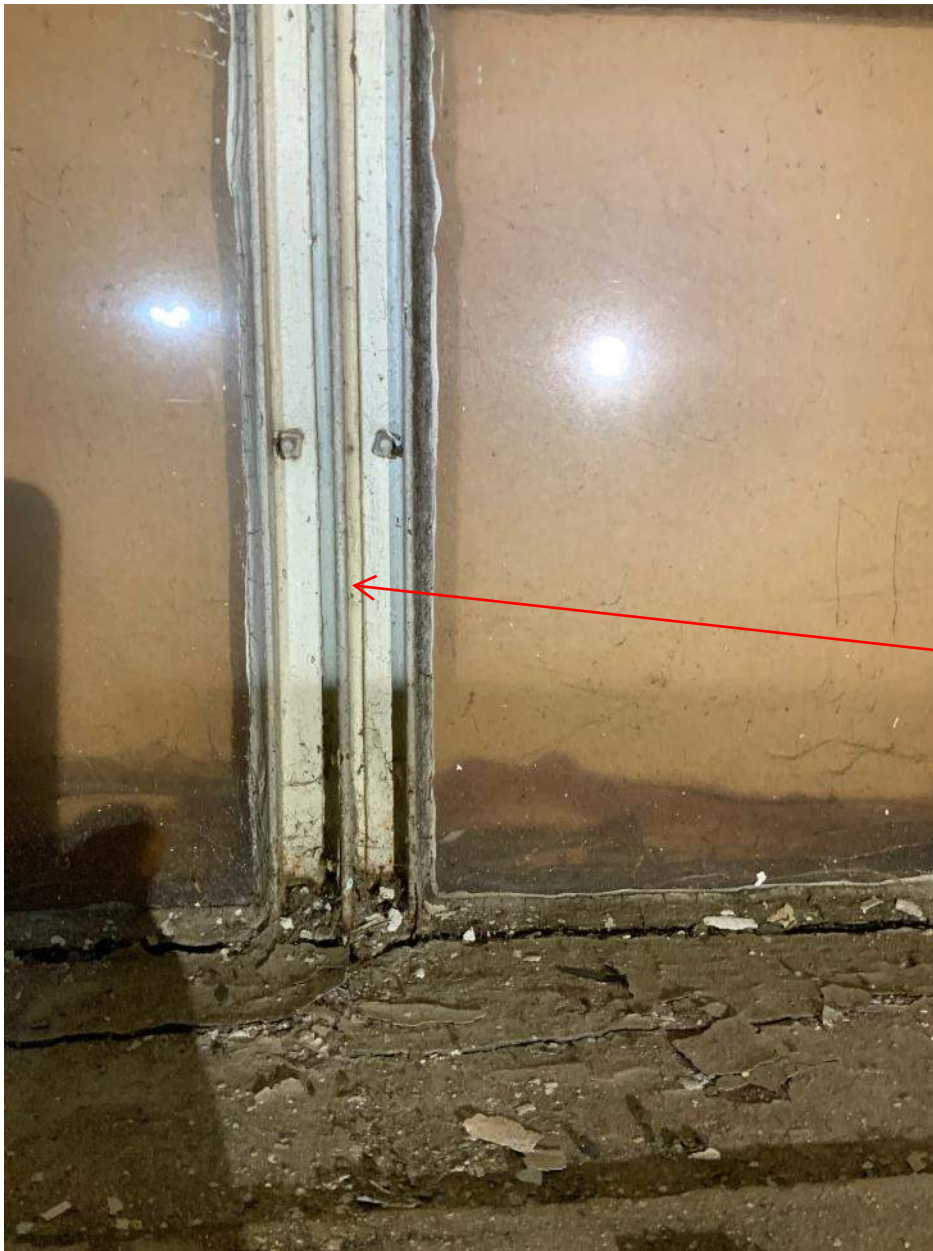
Steel Center Mullion

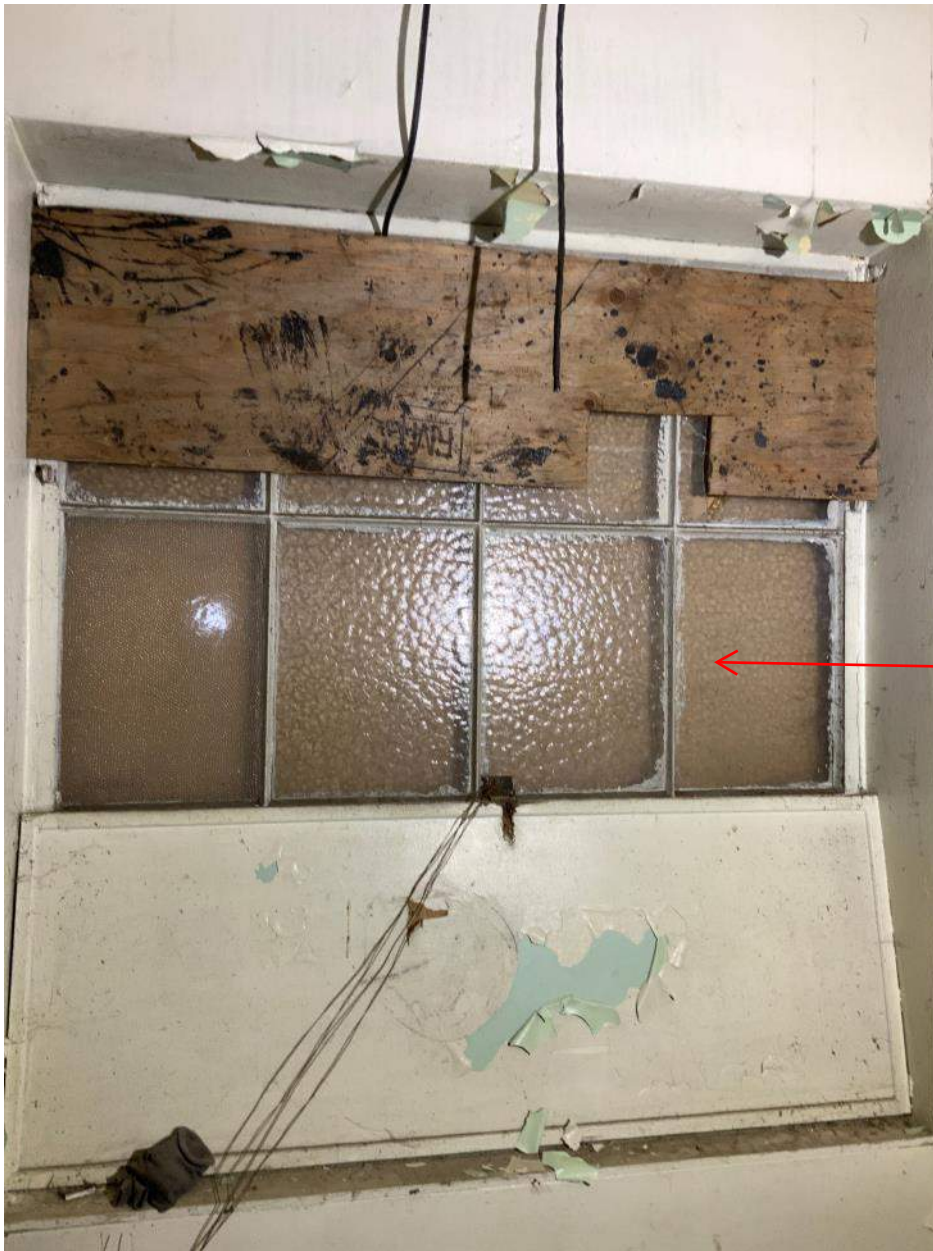
Historic Obscure
Glazing

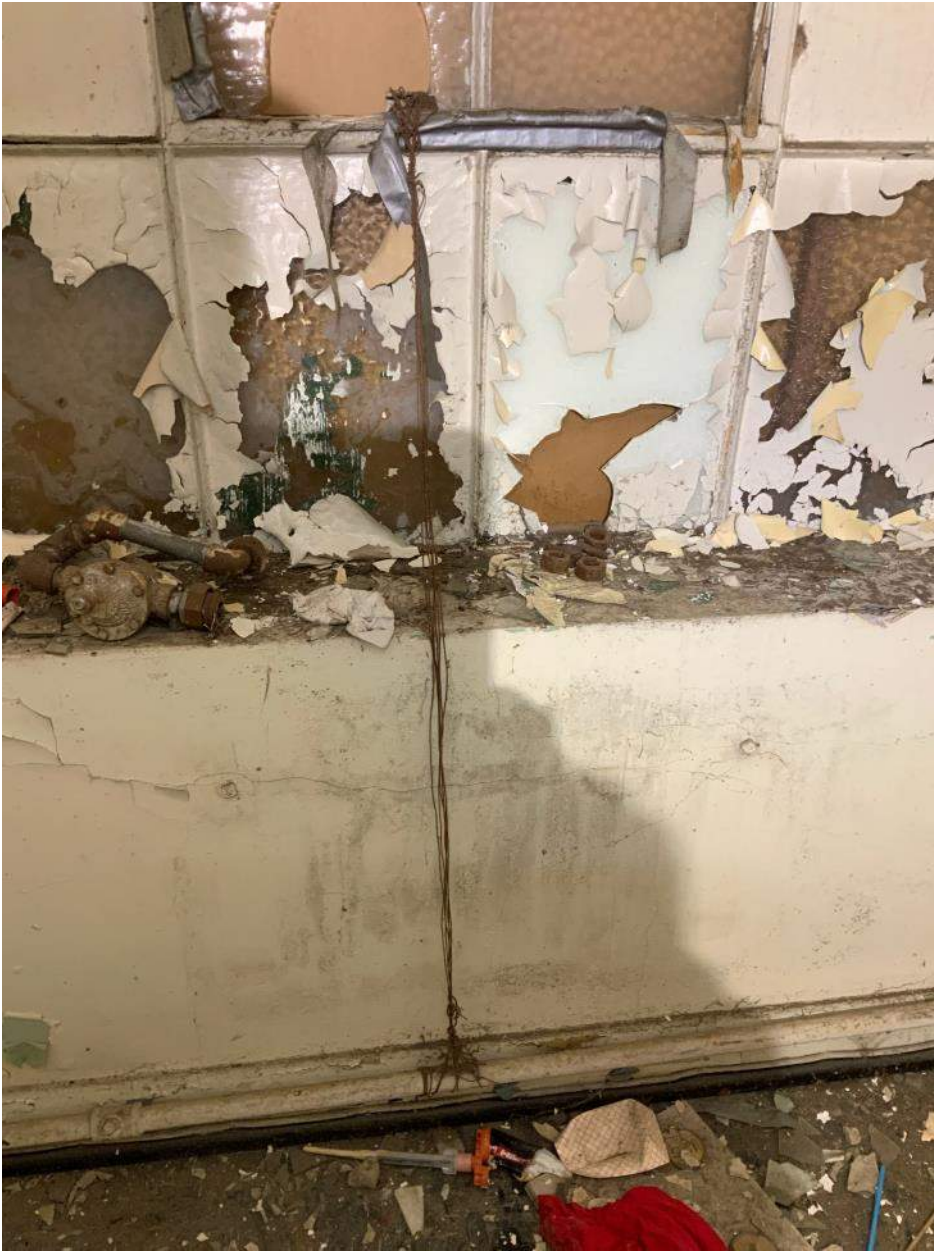
Rust is beginning to
form in the glazing bed

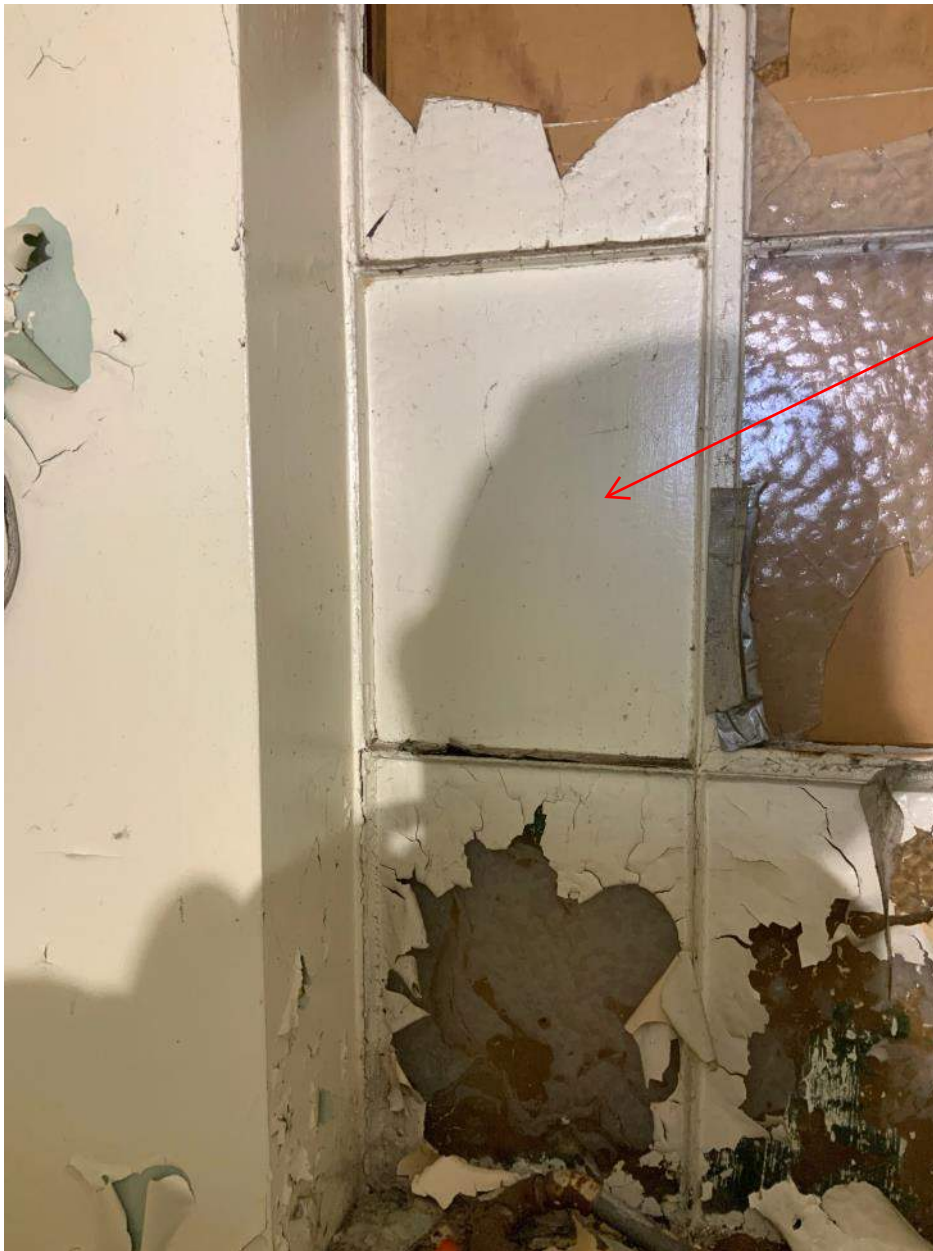
Painted obscure
glazing

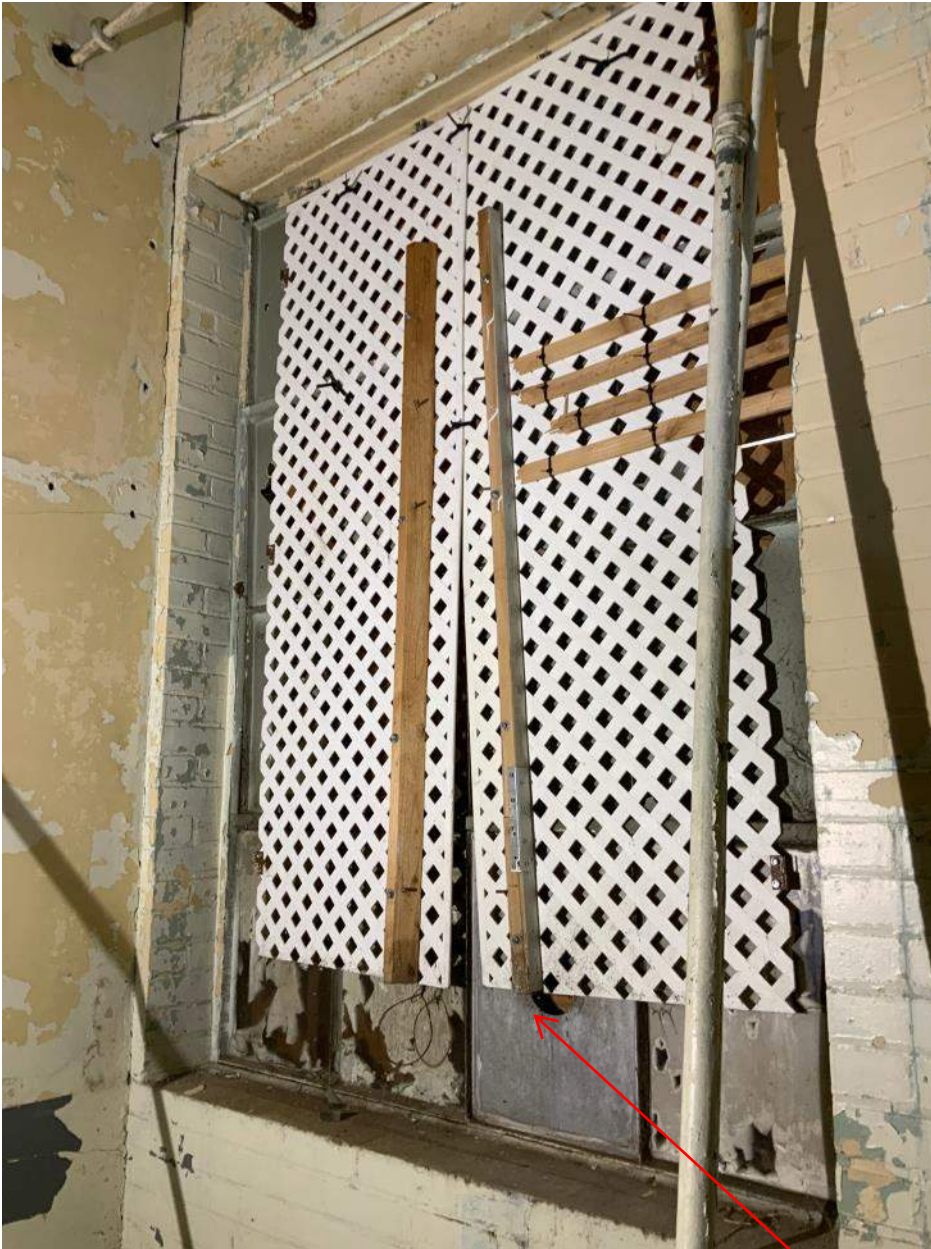
Mechanical louver

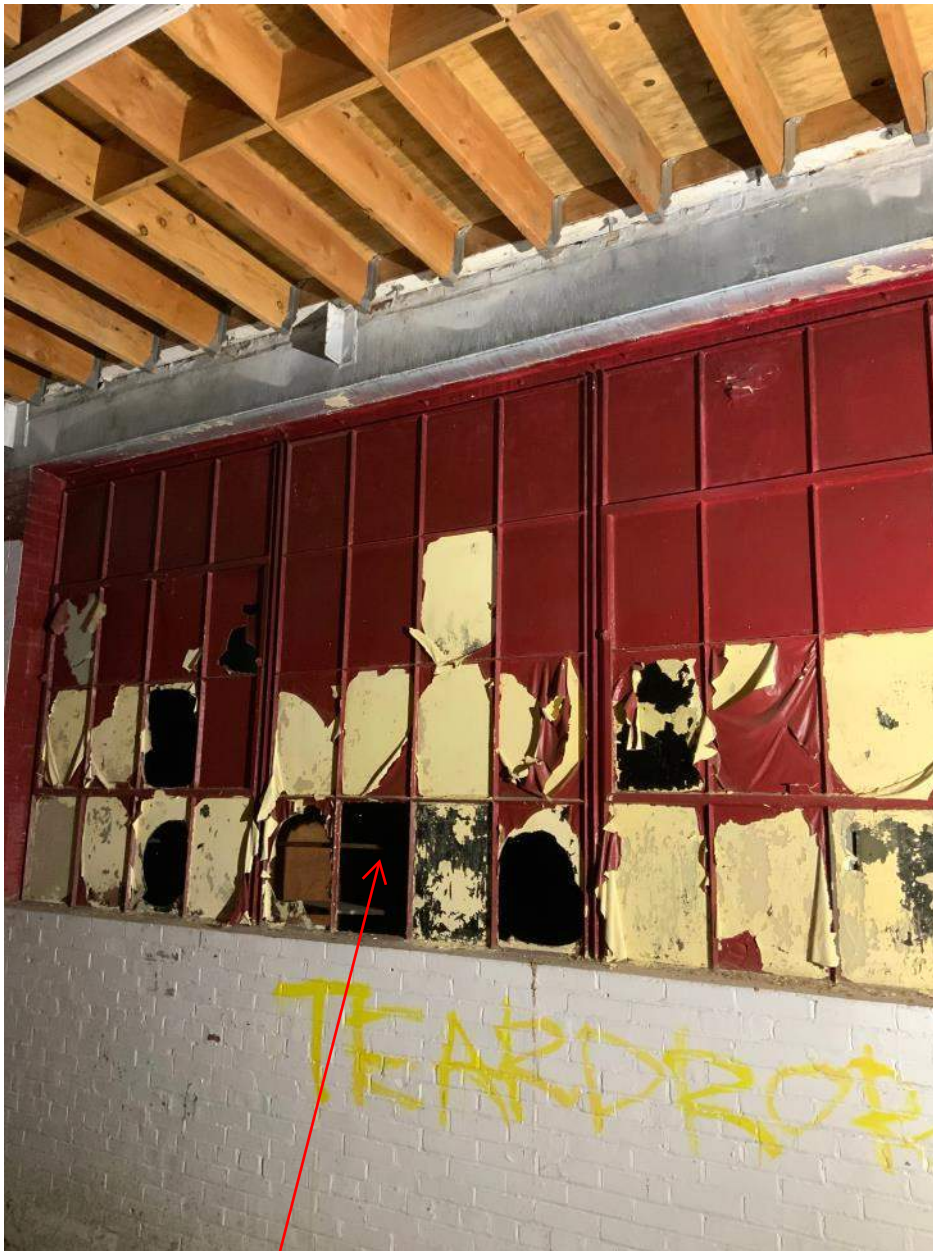
Sash is located directly
inboard of N-1-5.
There is no
salvageable hardware

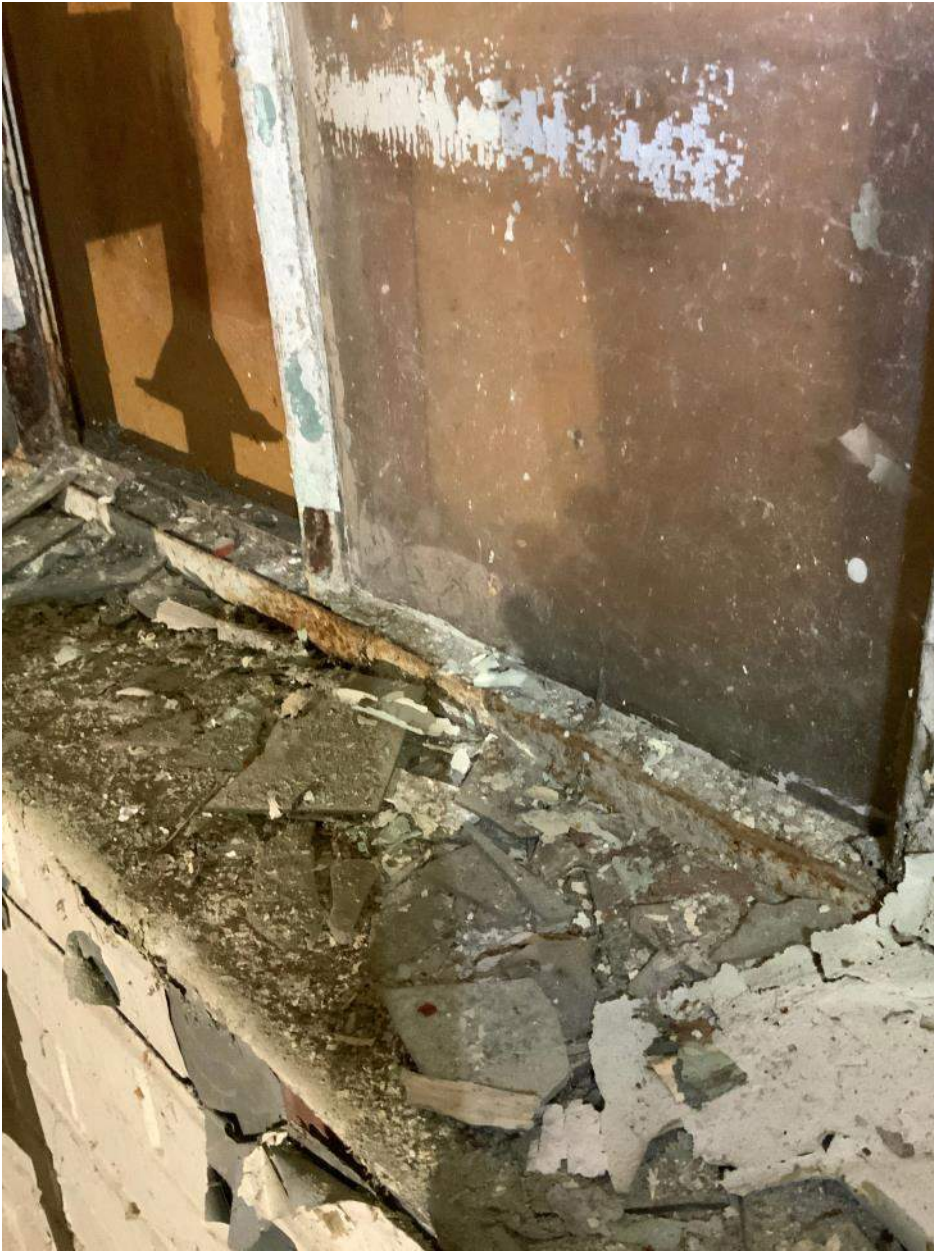
Rust is forming in the
glazing bed. Most
glazing is broken. This
Opening was also left
off of the current
elevations

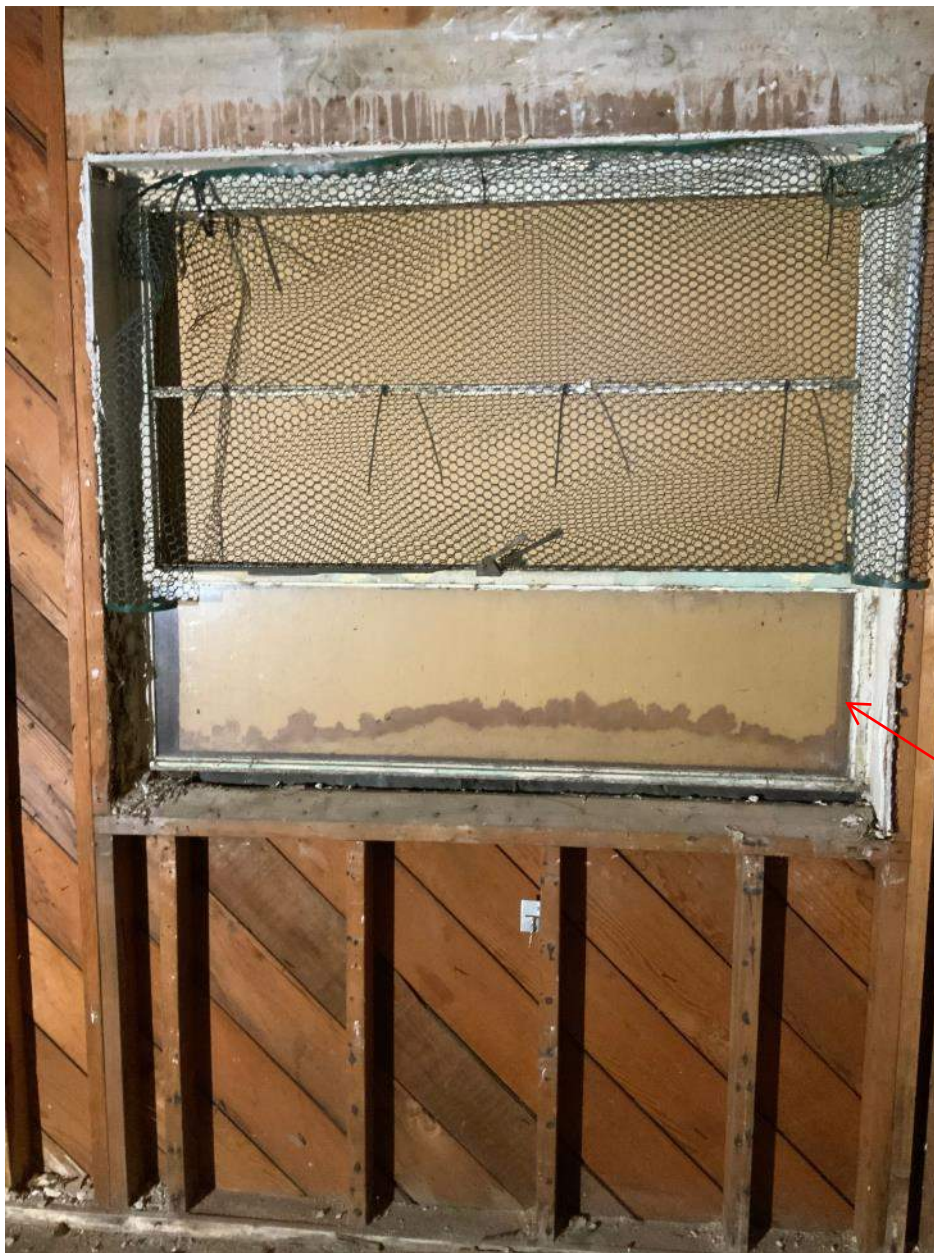
This style sash is
glazed from the
exterior

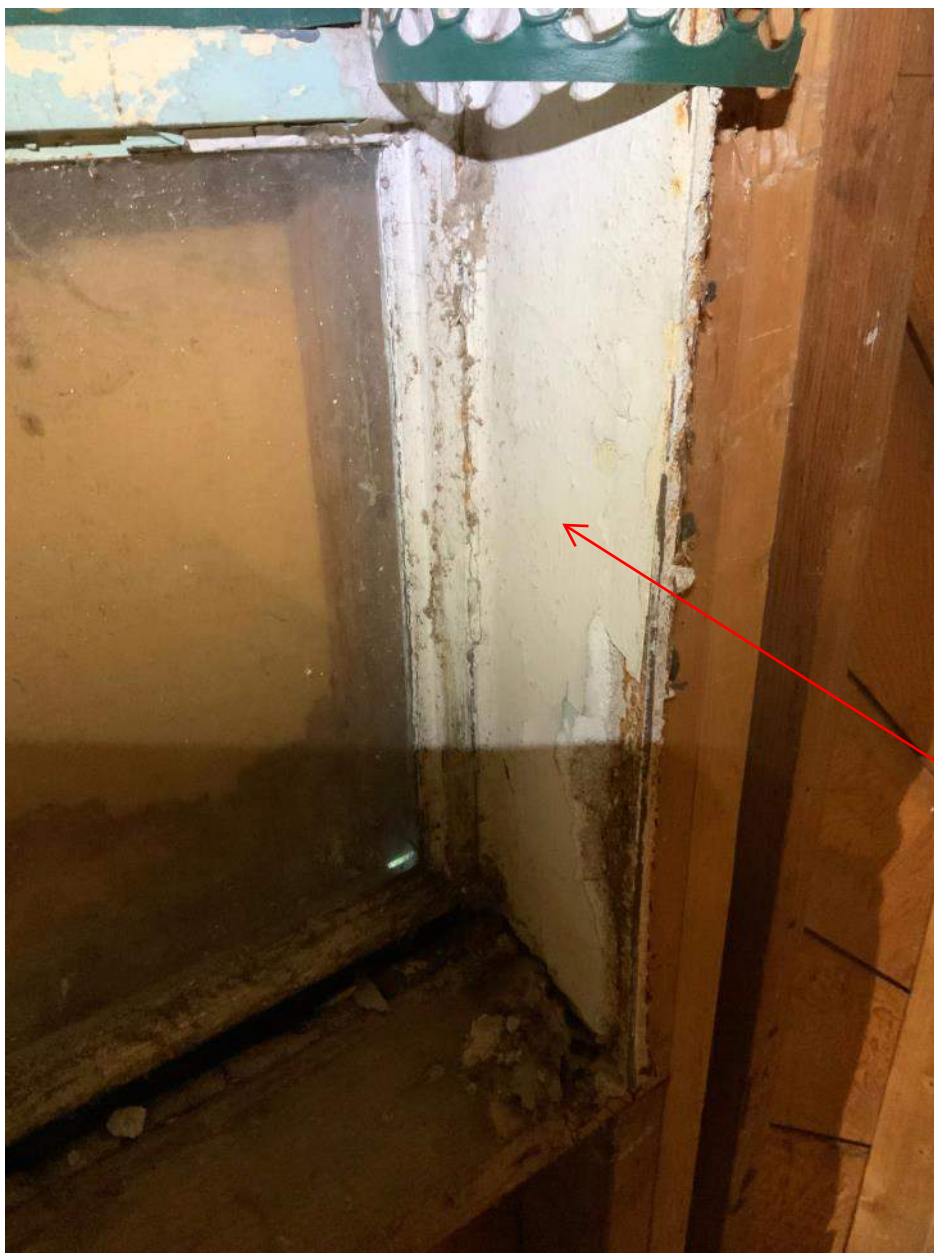
Plaster return directly
into sash

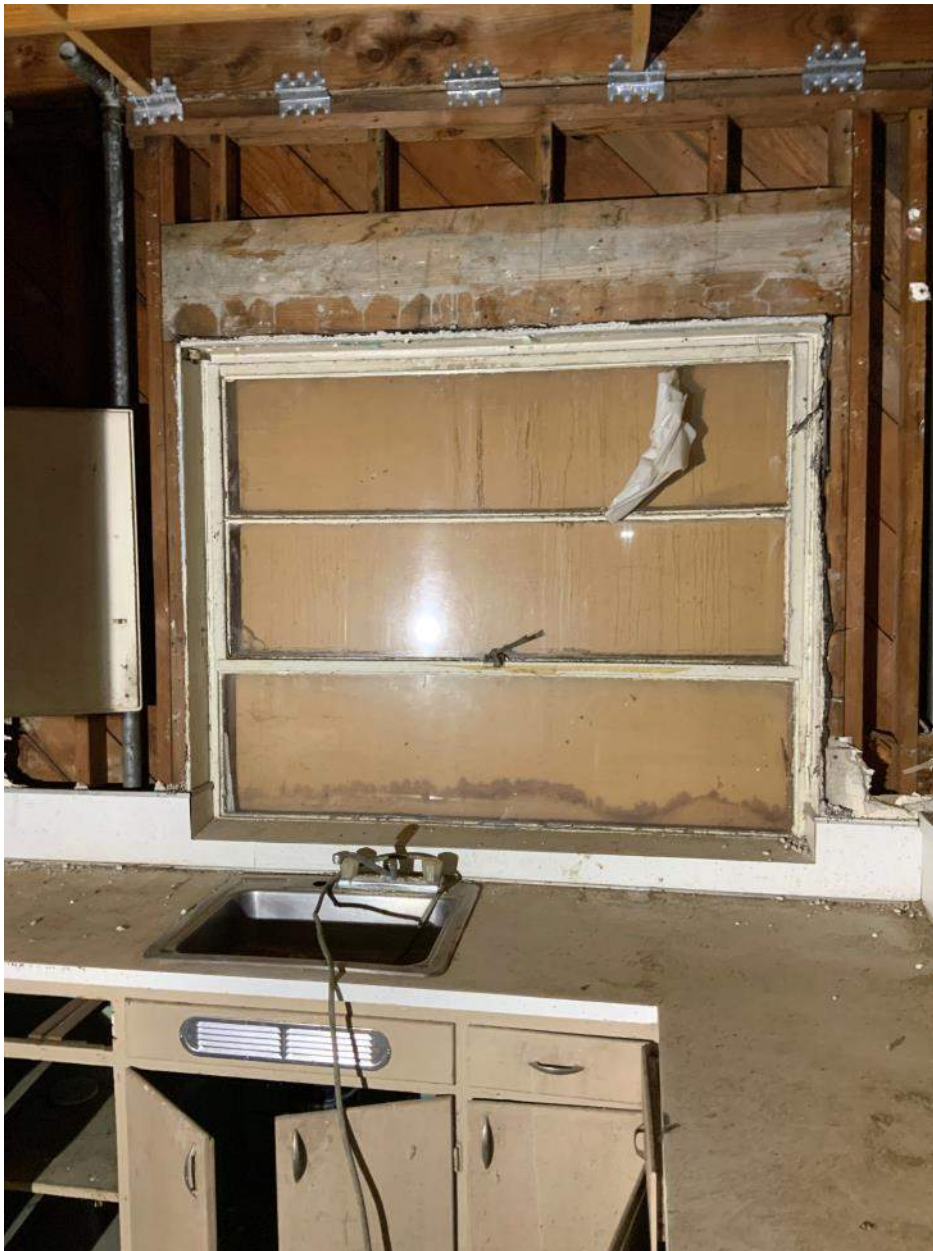
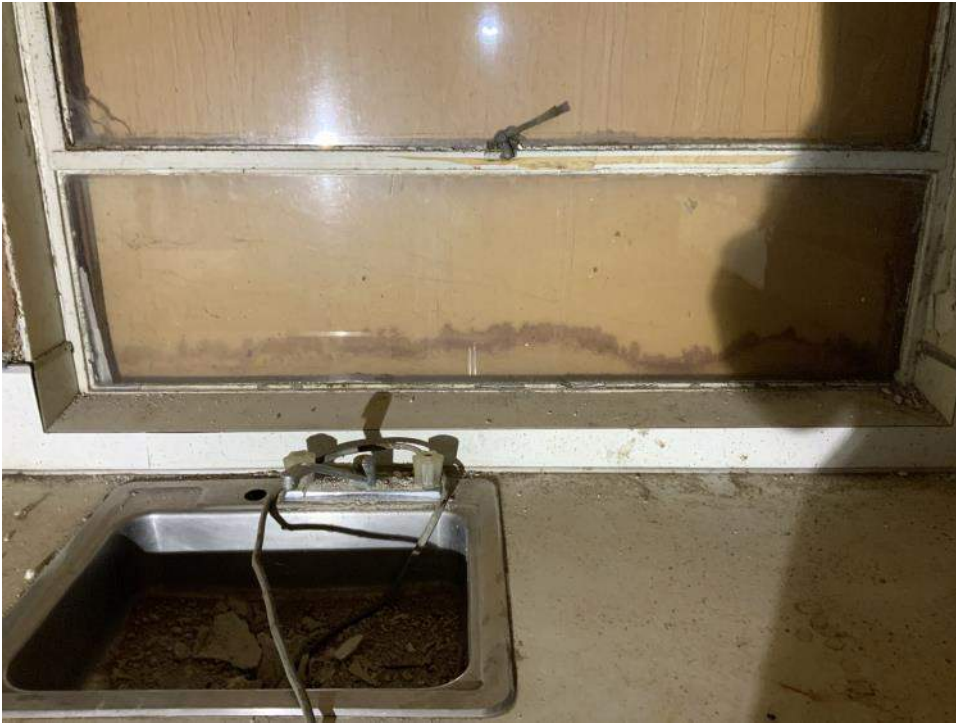
DESCRIPTION	Awning
WINDOW LOCATION	W-2-2
WINDOW CONDITION	Typical/Fair
HARDWARE	Casement Lock/ 2 Hinges
GLASS	1/8" Clear
CRITICAL DIMENSIONS	62"X52"

Back splash of sink tied to stool

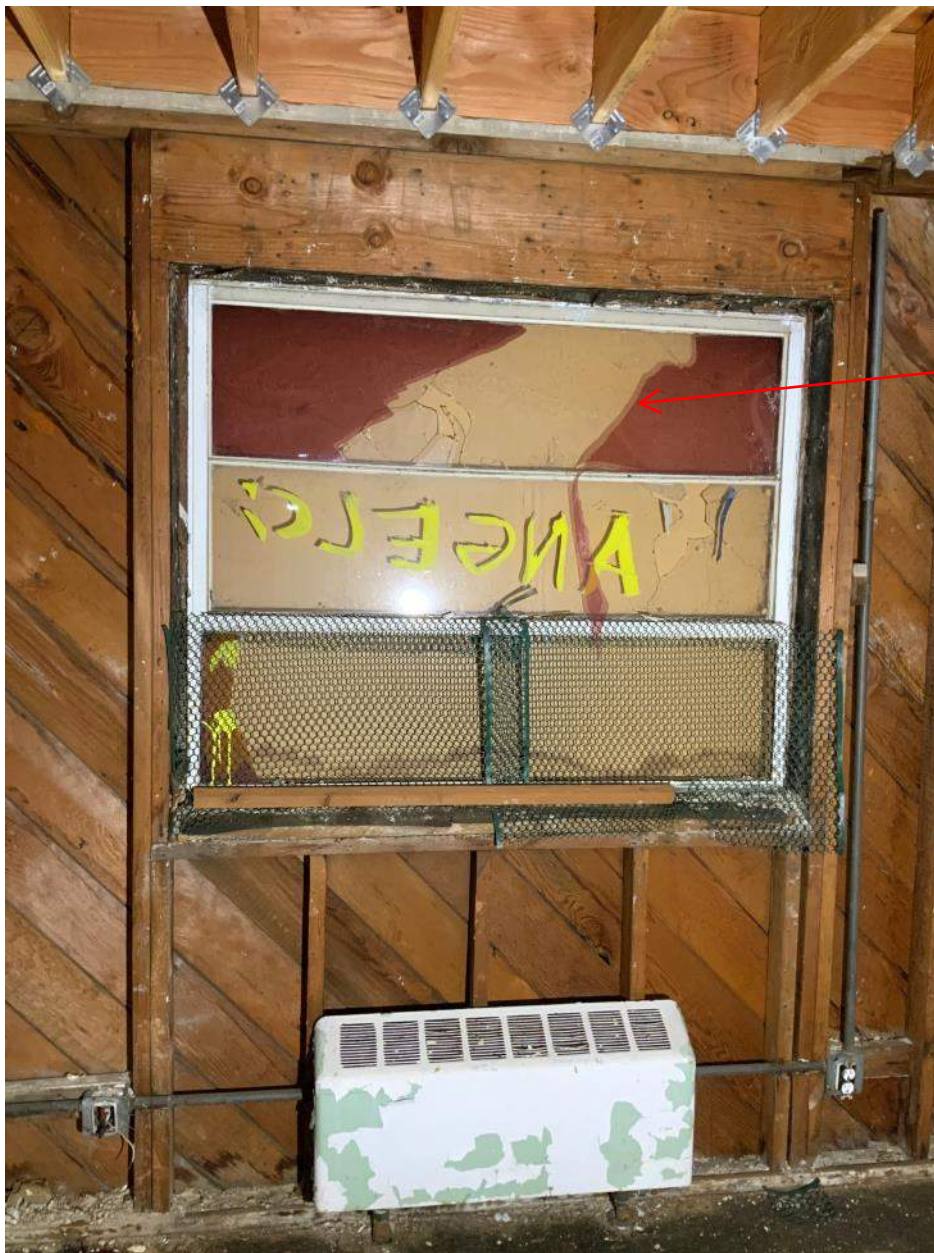
DESCRIPTION	Awning
WINDOW LOCATION	W-2-4
WINDOW CONDITION	Typical/ Fair
HARDWARE	Casement Lock/ 2 Hinges
GLASS	1/8" Clear
CRITICAL DIMENSIONS	62"X52"

Film on interior peeling off

Interior Film Peeling

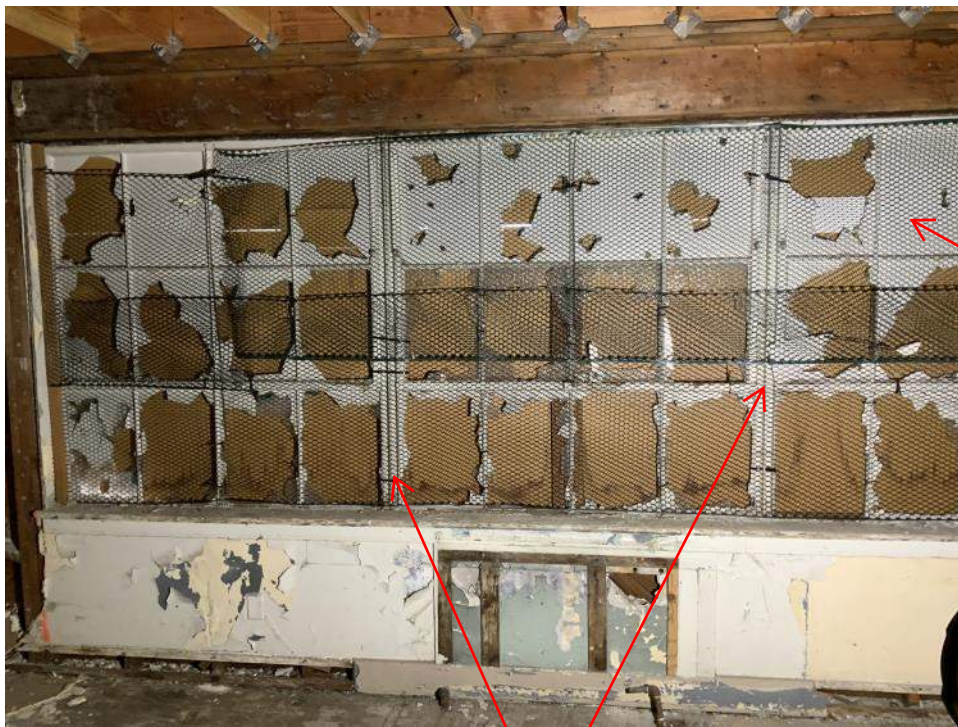
DESCRIPTION	Casement Mull
WINDOW LOCATION	S-2-1
WINDOW CONDITION	Typical/Fair
HARDWARE	Casement Locks at center operators
GLASS	Obscure/Painted Glazing
CRITICAL DIMENSIONS	62" X 180"

Painted Obscure
Glazing

Steel Mullions

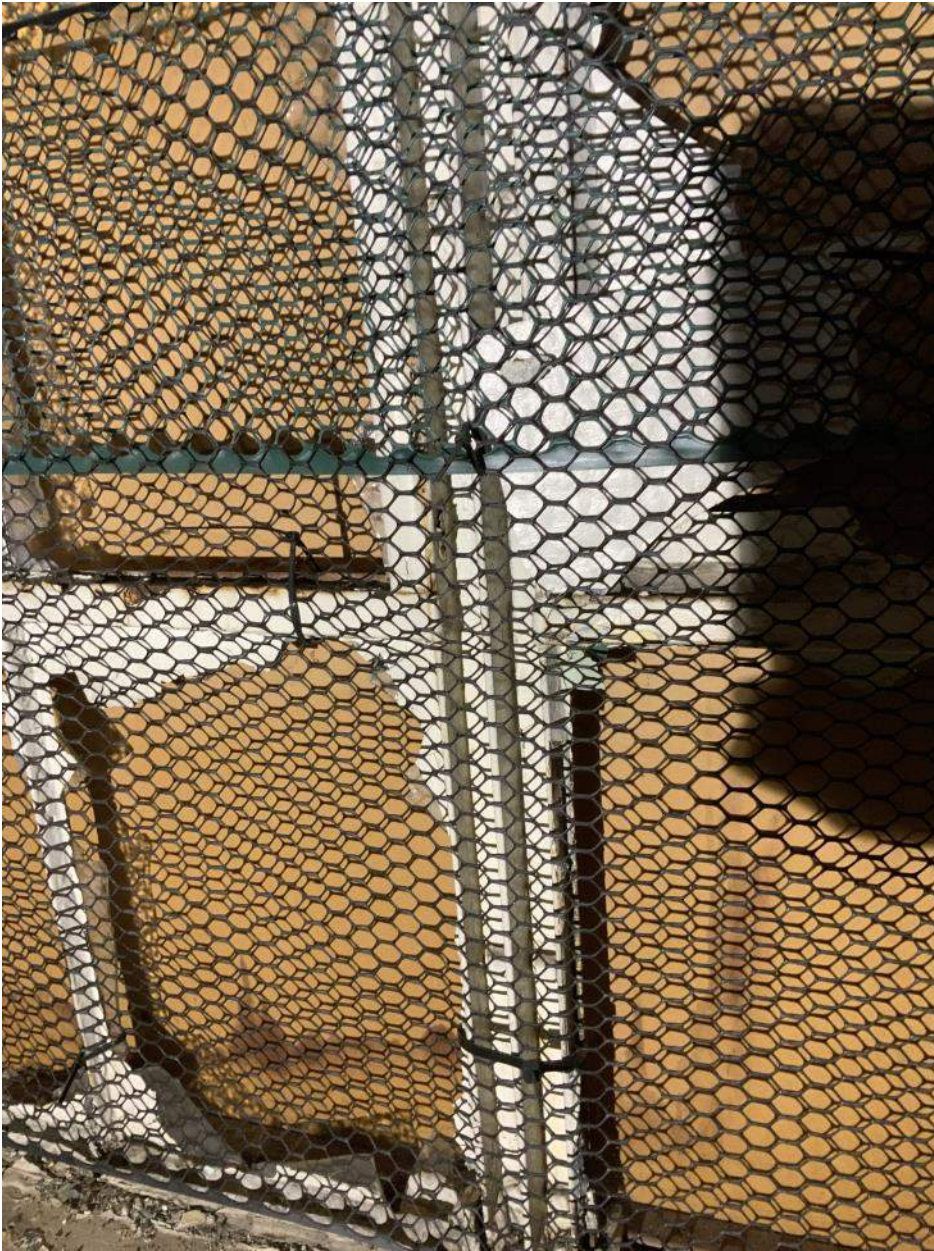
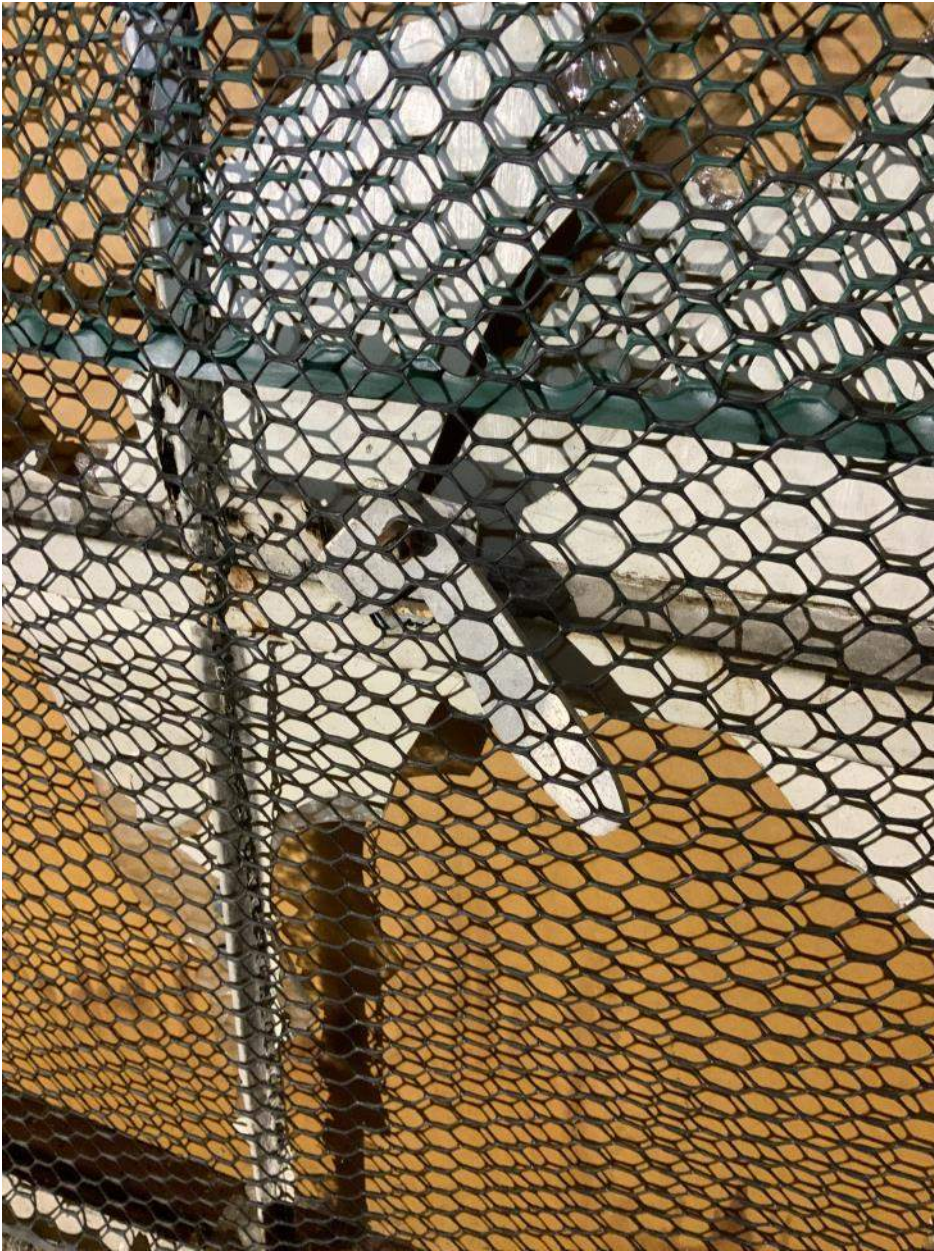
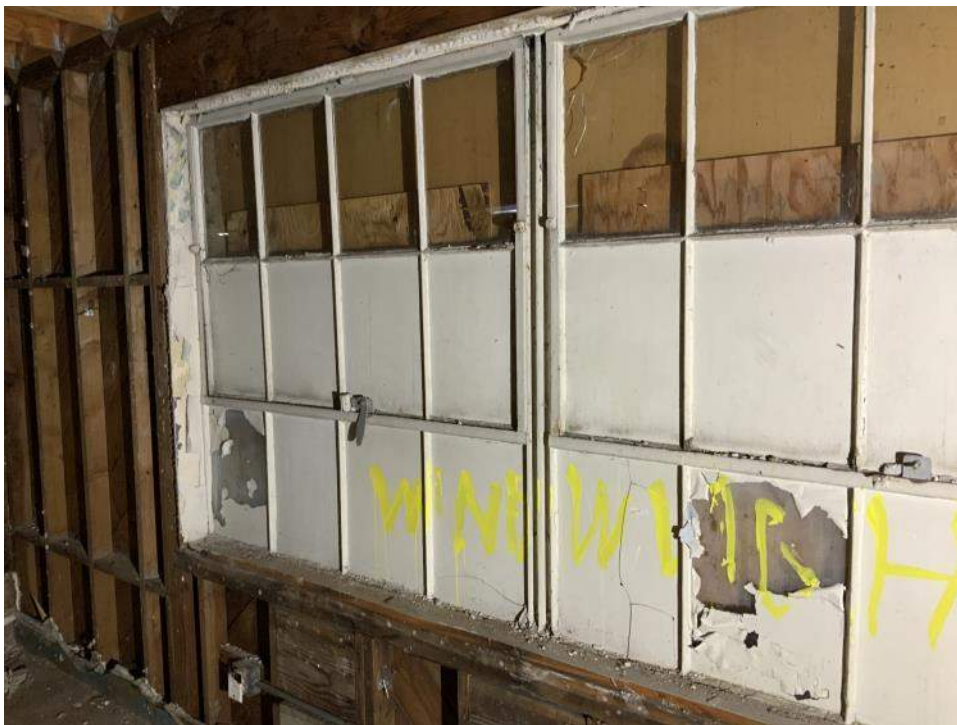
Hardware
missing/Broken
